Sediment Yield and Transport on a Mountainous Small Watershed

ASHIDA, Kazuo; TAKAHASHI, Tamotsu; SAWADA, Toyoaki

ASHIDA, Kazuo ...[et al]. Sediment Yield and Transport on a Mountainous Small Watershed. Bulletin of the Disaster Prevention Research Institute 1976, 26(3): 119-144

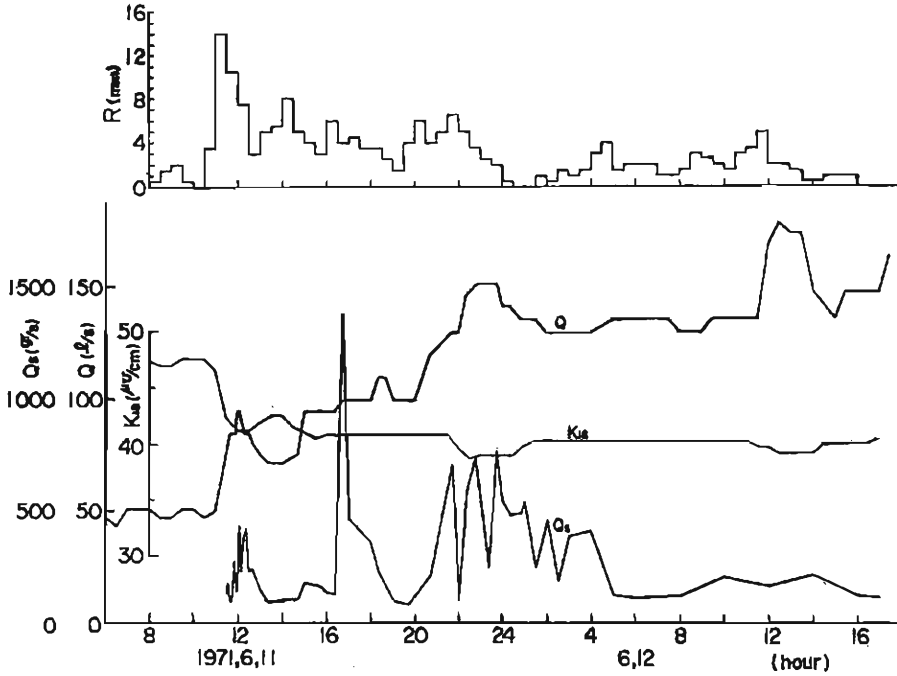
Fig. 7. 1971.6. Flood at Hirudani Station.

As was noted for the cases above, sediment discharges are high in the rising phase, but in the recession or in the less variable flow phase, sediment discharges tend to decrease, notwithstanding that the flow rates are still high. Fig. 9 shows the particle size distributions in samples collected at Hirudani Station during 1971.6 Flood.

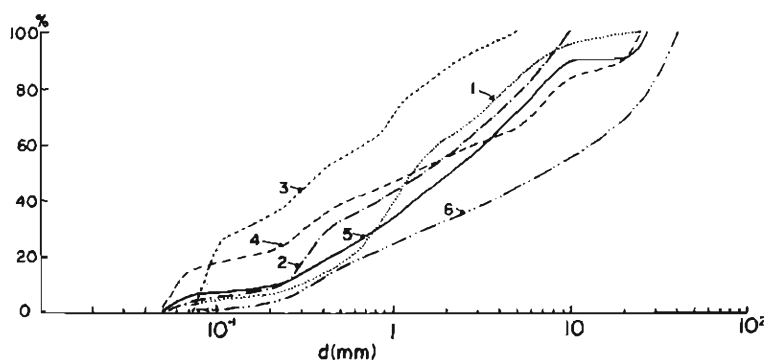
Fig. 12. Particle size distribution in the samples during the flood. 1; Sampled from the surface of landslide, 2; 11:00, 11th, July, 3; 21:00, 11th, July, 4; 21:10, 11th, July, 5; 6:10, 12th, July, 6; 22:00, 13th, July.

More detailed aspects of the phenomena were as follows:—Sediment runoff during 10th July corresponded to either rainfall or flow discharge. The majority of grain size of sediment at that time was less than 2 mm and the median diameter was 1.2 mm. Materials which run off were mostly soil and pieces of wood and grass. This is probably due to the fact that this was the first flood of the year by rainfall. The first peak of rainfall intensity for the second flood occurred between 20:30 and 21:00, 11th, July. Coinciding with the rain, the flood occurred and sediment discharge increased. Flow materials at that time were again mostly soil and pieces of wood and grass. The sediment discharge at 21:00 was up to 3300 grams per second under a flow rate of 240 l/s . Then the flow rate increased up to 300 l/s , but the high concentration did not last long, namely, at 23:30 the sediment discharge damped to 300 grams per second. It was when the color of water changed from dark brown to red brown and the percentage of particles larger than 2 mm increased. This should imply that the bed load had reached the station. From that time on, the sediment discharge again increased and fluctuated making a few peaks, but these peaks had no correlation with peaks in flow rates or rainfalls. After 12 o'clock of 12th, July, sediment discharge decreased to 250 grams per second, without any reduction in size of run off sediment, while the flow rate at Hirudani Station was still rising. Particle size distribution in the samples during the flood is shown in Fig. 12.

Fig. 13 shows the petrographical classification of sediment discharge for various grain-size diameters. Fig. 12 and Fig. 13 indicate that the run off sediment was mostly granite-porphry originating from the landslide on C-Watershed.

Fig. 9 and Fig. 12 show that the run off of granite-porphry sediment is very similar in size distribution to that sampled at the site of production as long as the flow rate is higher than some threshold value. This implies that the tractive forces of the flow in the stream for such cases exceed the threshold value to transport the maximum size particles in produced sediment. But, if one assumes the tractive force is far beyond the threshold value and almost all sediments are transported in suspension, he should come to the conclusion that there should exist a negligible time lag, at longest ten minutes, between water flow hydrograph and the sediment discharge hydrograph. However, observed lags, as shown in Fig. 16, sometimes exceed ten hours. These results suggest the majority of sediments are transported, at least up to the flow rate of 100–150 l/s , as contact load. The cases which have practically no lag time would imply that there has been much stored sediment on the bed and side banks of the stream channel to be picked up and transported as contact load. So lag time and quantity of runoff would be affected by the antecedent storage of sediment on the stream channel. This storage should be given as a process parameter in the channel process subroutine.

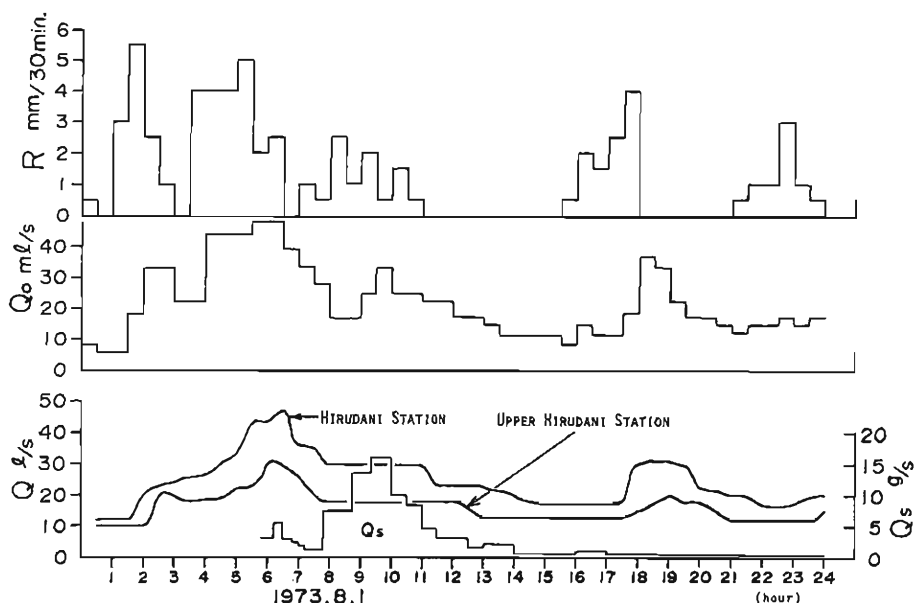
Fig. 14. 1973.8. Flood. Q_o : Spring discharge.

Rain in 1973 was very scarce. The small scale flood on the first of August was the only one occasion for observation. Measurement of the discharge from the spring at the top of the landslide on C-Watershed commenced from this year. Q_0 in Fig. 14 indicates this discharge. The runoff pattern of Q_0 corresponds rather well to that of rainfall, with half or one hour lag, and also resembles the hydrograph at Hirudani Station.

Turbidity in river flow began 5:30 of 1st, August. From that time on, although the volume was small, the sediment runoff occurred in correspondence to the hydrograph until 7:50 a.m.. Abruptly from 7:50 a.m., sediment discharge increased, forming a peak and then decreased, meanwhile the flow rate was almost constant. From 17:30, the flow rate again increased, but the sediment runoff no longer in-

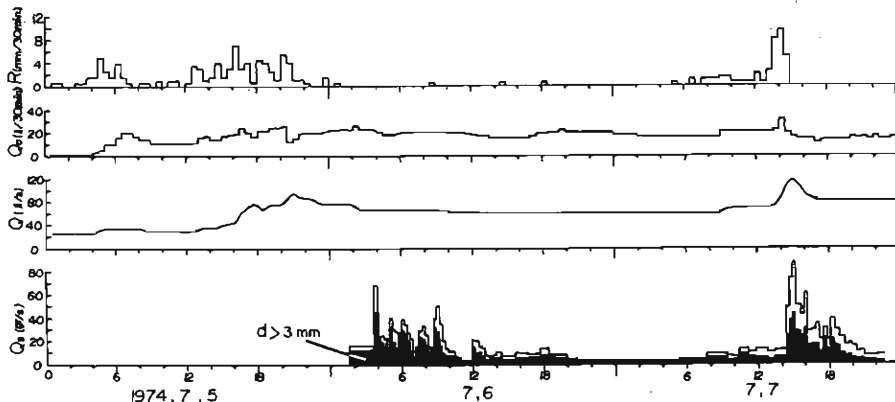
Fig. 16. 1974.7. Floods.

For the case of the first flood, turbidity in the flowing water began to be observed with the beginning of rise in flow rate, but the measurable amount of sediment reached the station about ten hours later. On the other hand, for the case of the second flood, the peak of sediment discharge well corresponded to the peak of flow rate. This was the first time such a long lag between hydrograph and sediment runoff had been observed. Eighty to ninety percent of the run off sediment was granite-porphry and the andesite, which was very scarcely distributed along the stream channel. This would mean that the sediment was mostly transported from C-Watershed. In this flood sediment particle sizes were rather large and about 80 percent of them were larger than 3 mm. Remarkable fluctuation in sediment discharge under constant flow rate is another characteristic of this flood.

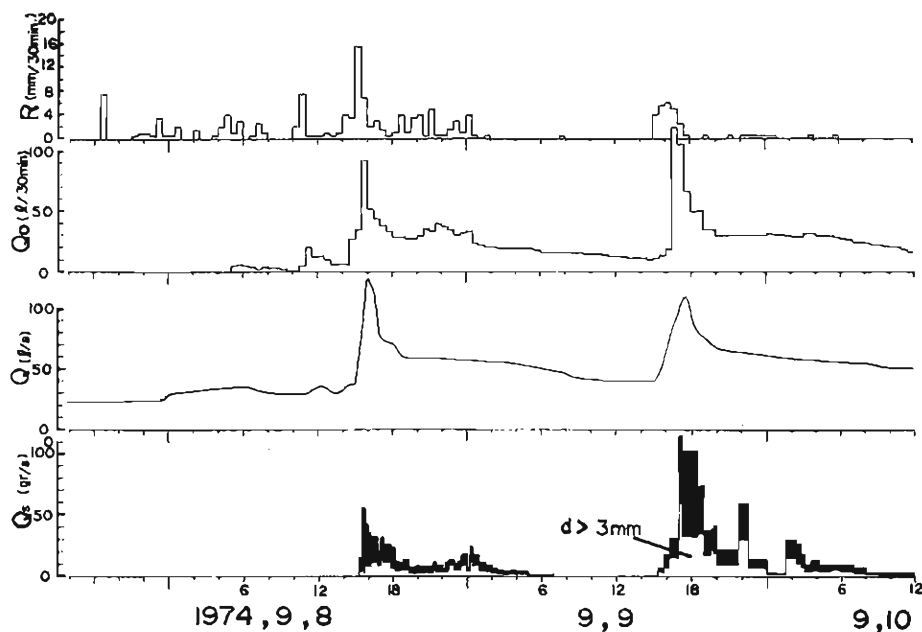
Fig. 17. 1974.9. Floods.

These flood happened following the flood described above. Sediment runoff in these floods well corresponded to the flow rate. Petrologically, the sediment was, as the previous floods, mostly granite-porphry, but its size was finer than previously.

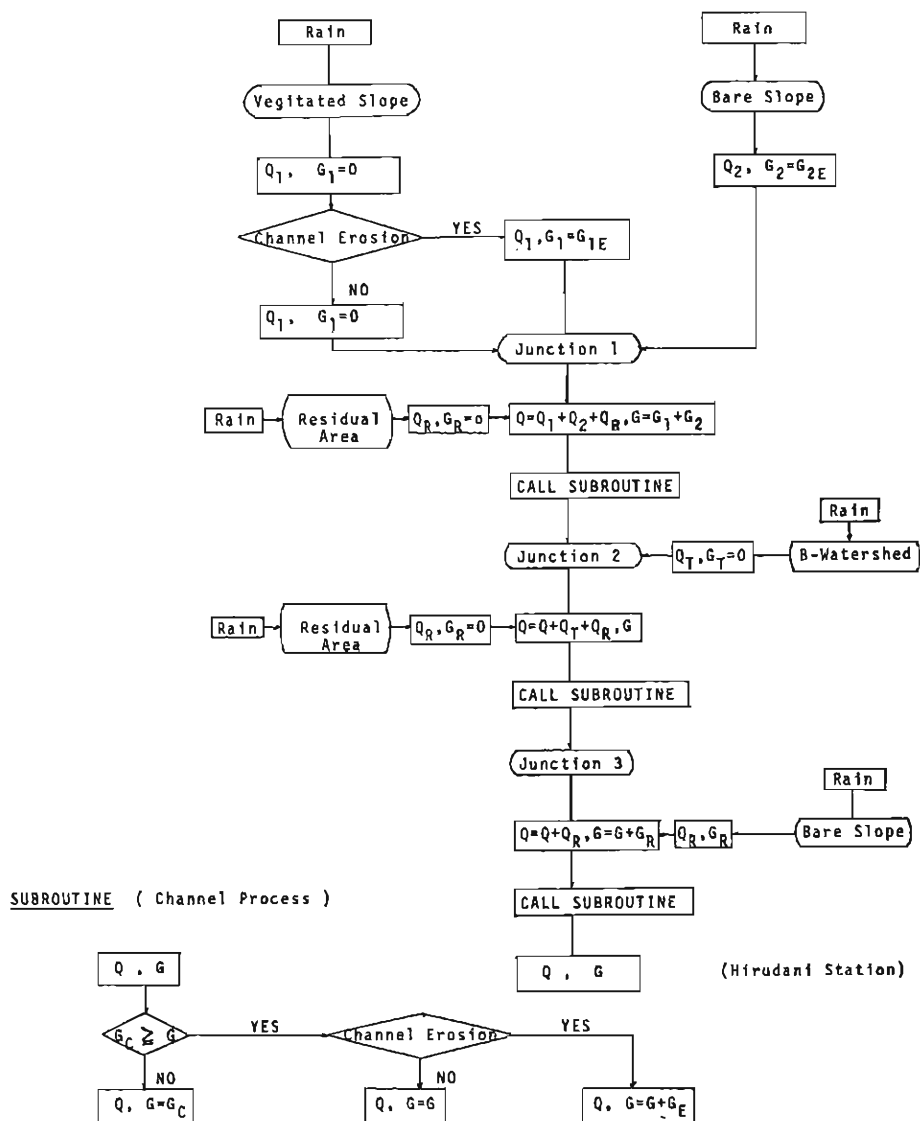
Fig. 23. The flow chart of sediment runoff process in Hirudani watershed.

Fig. 23 shows a flow chart of related processes in Hirudani. Since no new landslide has happened and no sediment from B-Watershed has been produced, sediment runoff due to the occurrence of landslides or that due to the surface erosion of the covered area are omitted from the flow chart. Of course, this does not necessarily

Q : Flow rate, G : Sediment discharge, G_E : Sediment discharge due to erosion, G_c : Sediment transporting capacity.

Suffix 1, 2, R and T respectively mean 1, 2, residual and tributary basins.

It will be understood from Fig. 23 that the channel process shown as "SUBROUTINE" is critically important to the phenomena. It is where the run off sediment is stored or increased in volume by scouring and as the consequence of these channel processes the sediment discharge hydrograph is transformed. The first consideration in developing the channel process model is to identify the mode of transportation either as suspension or as contact load. Unfortunately, there is no observation data of the actual flow on the stream channel during flood, and so one must guess the mode of transportation from the available data.

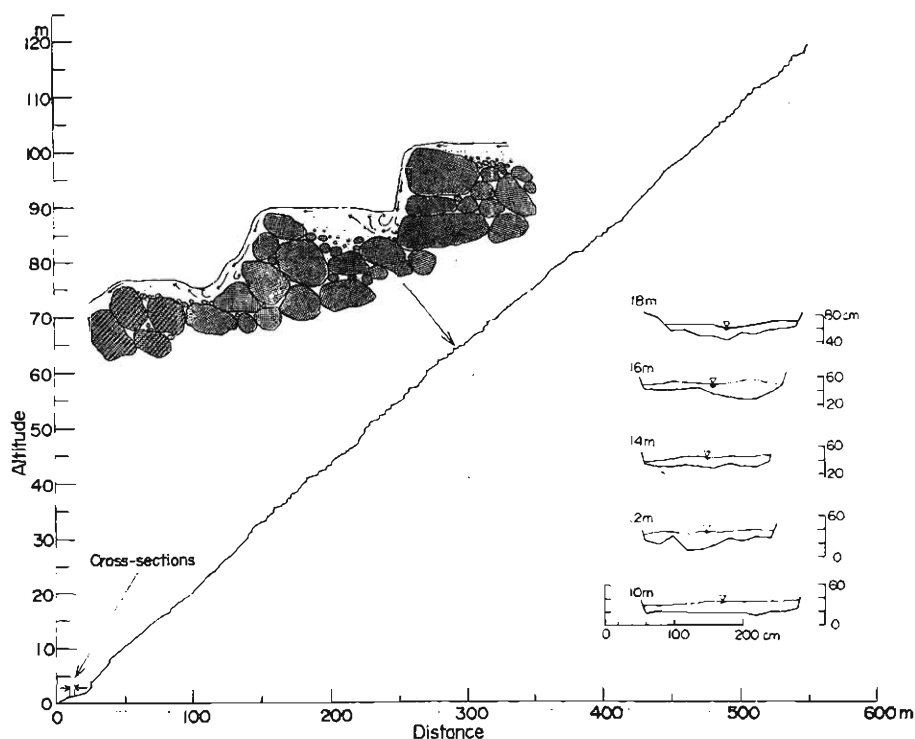
Fig. 26. Longitudinal profile and some representative cross-sections in the Hirudani.

The stream channel is composed by linking of many pools and falls as shown in Fig. 26 and Photo. 1. The sediments are mostly deposited, as checked by field survey, at some distance downstream from the bottom of a waterfall, where the sediment to be transported covers the armoured surface and reached an equilibrium state. The slope of energy line at this part of the stream should change in relation to the flow rate from nearly horizontal in case of lower flow up to some percents in case of higher flood; notwithstanding the steep topographical inclination, the effective slope should be much flatter. Assuming a linear effective energy slope variation from 0.002 for 50 l/s to 0.01 for 400 l/s and further assuming that the breadth of the water surface obeys regime theory, i.e. $B = 5Q^{0.5}$, one would be able to calculate sediment discharges using, say, Meyer-Peter and Muller's equation. Cross-sections shown in Fig. 26 imply the regime theory is one reasonable approximation, at least at this flow rate. Fig. 27 shows the results of calculation and observed data. Less amount of storage than that in an equilibrium should result in smaller sediment discharge, so the equilibrium state should be in correspondence to the maximum sediment discharge under particular flow rate. The tendency of the results in Fig. 27 seems to be acceptable.
